CASE REPORT

FRACTURE OF AN EXETER™ V40™ STEM THROUGH THE INSERTION GUIDE HOLE AND REVISION USING CEMENT-IN-CEMENT TECHNIQUE

Royal Lancaster Infirmary-UK

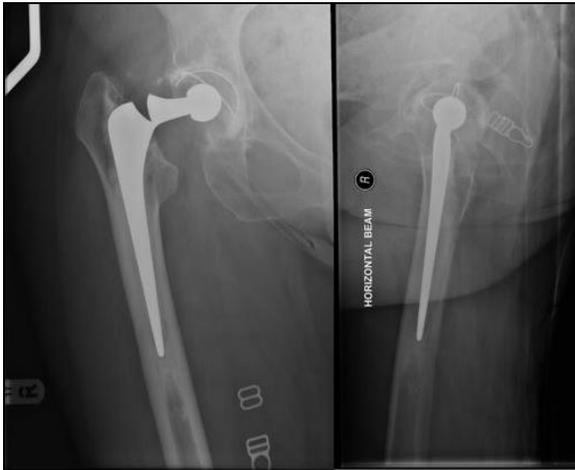
of the proximal 1/5th and distal 4/5th [Figure-1]. The distal stem appeared well-fixed, with no osteolysis around the cement mantle.

Figure-1: Antero-posterior & lateral radiographs indicating fractured Exeter™ stem

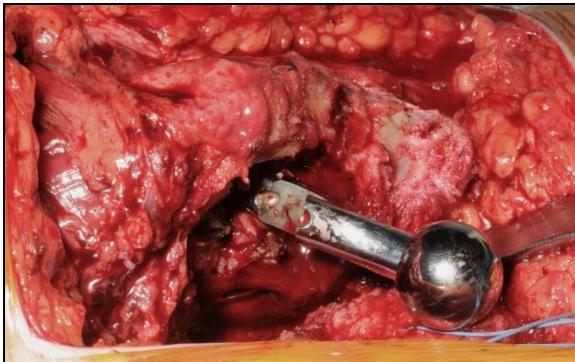
Following a fully informed discussion, the patient underwent revision THA with a posterior approach. A stem breaks concurrent to that seen on the radiographs was noted [Figure-2]. A 22mm head, with an Exeter™ V40™ stem (size-0, 44mm offset, length 150mm) was in situ. Fracture fragments were still attached at the inferior aspect [Figure-3]. The stem was extracted very carefully without need for a cortical window or extended trochanteric osteotomy. Both fracture fragments separated with minimal force [Figure-4]. The cement mantle was noted to be pristine. A small area of proximal cement clearance was carried out. Wear was noted on the acetabular component; hence the cup was also revised. The socket was reamed out and cement was extracted without causing bone loss. The acetabulum was sequentially reamed up to 51mm. A definitive 45x28 Marathon™ cup (DePuy Synthes, MA, USA) was inserted using CMW2 cement. Trial with size 1 C-stem™ (DePuy Synthes, MA, USA) and a 28mm +0 head was satisfactory. A definitive size 1 standard offset C-stem™, with 28mm +0 metal head, was inserted using CMW1 cement using cement-in-cement technique. The hip was stable on reduction. Routine closure was performed.

Figure-2: Intra-operative image of prosthetic fracture

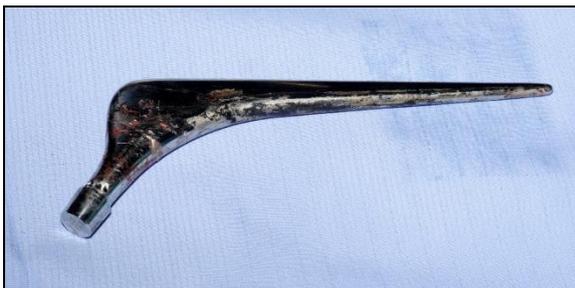
Figure-3: Intra-operative stem retrieval. Fracture fragments still attached at inferior neck-shaft aspect

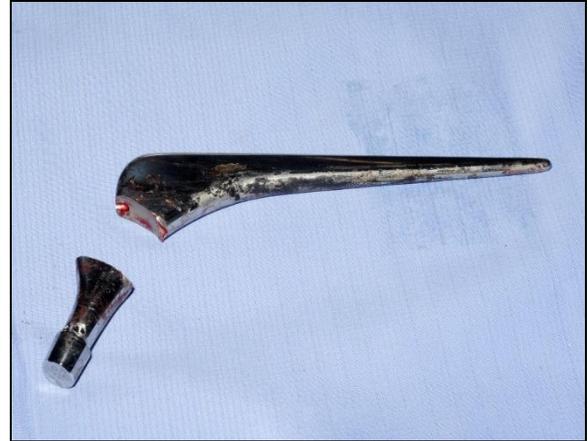
Figure-4: Fracture fragments separated with minimal force

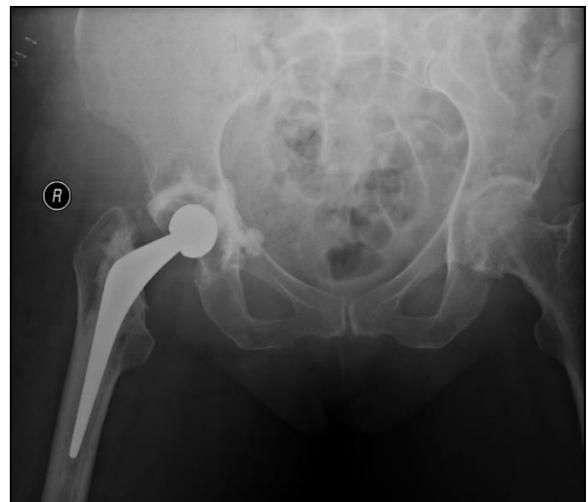
Post-operative radiographs were satisfactory [Figure-5]. She was advised to mobilise with two sticks for six weeks at least. At six weeks she was

Figure-5: Post-op revision hip arthroplasty radiograph

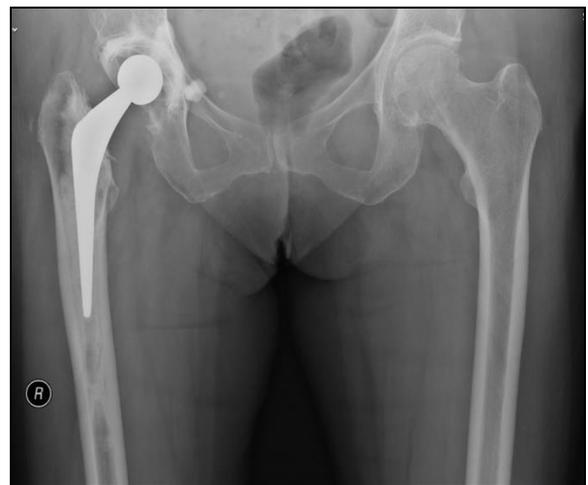
fully weight-bearing comfortably but was advised to continue using one stick as precaution. She was unable to attend 3-month follow up. At six months, she was mobilising extremely well and back to baseline activity level. Radiographs were satisfactory with the implant in situ in her right, but also indicated some asymptomatic early medial left hip osteoarthritis [Figure-6]. She is still doing very well at most recent follow-up at 12 months.

Figure-6: Six-month follow up. Some early medial left hip osteoarthritis noted. Prosthesis position satisfactory

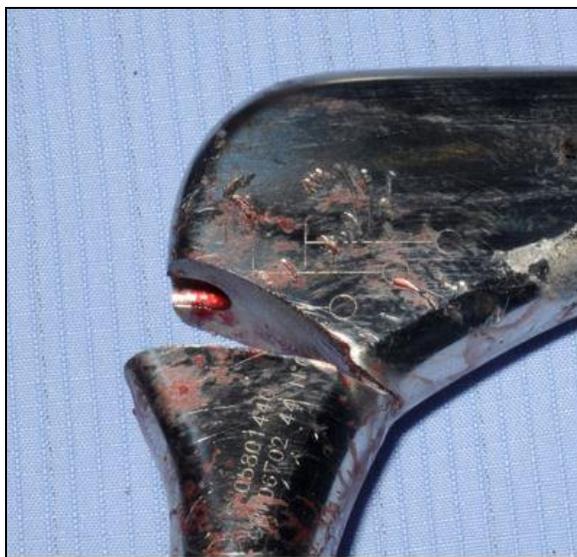
Figure-7: Stem retrieval image indicating fracture at neck-shaft junction

The three other reported cases occurred at the neck-shaft junction.^{7,9,10} These atypical fractures are thought to begin around the insertion guide hole at the antero-superior neck and propagate inferiorly.¹⁰ In one case, a 71 kg patient underwent primary THA using cemented 44-mm offset size 0 Exeter™ V40™ and 28mm +0 head, which eventually fractured.¹⁰ In another case, a patient (BMI 27.8 kg/m²) underwent cement-in-cement revision THA with a 44-mm offset 125mm ("small") Exeter™ revision prosthesis, which subsequently fractured.⁹ In the third, the patient (BMI

Our patient's fracture matches this previously described unusual pattern [Figure-7].^{7,9,10} Due to the sudden nature of her presentation, it is difficult to determine if the stem fracture happened gradually or if due to sudden stem failure. However, sudden stem failure is more likely, considering she reported experiencing no pain, weakness or altered sensation in her right hip prior to feeling it give way.
