## **CASE REPORT IMPLANTATION OF THE PERMANENT PACEMAKER; FROM** SUPERIOR VENA CAVA IN A PATIENT WITH FIBROSIS OF BOTH SUBCLAVIAN VEINS

Citation: Shah B, Khan B, Saidullah S. Implantation of the permanent pacemaker; from superior vena cava in a patient with fibrosis of both subclavian veins. J Ayub Med Coll Abbottabad 2021;33(3):523-5.

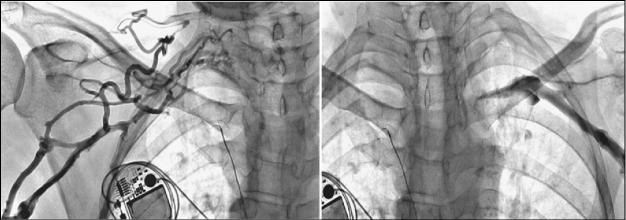
Figure-1: Blocked veins visible on both sides, collateral is visible

The left side was clear from infection now. A venogram performed to see whether we could do implantation on this side now. The vein was badly fibrosed and implantation of device on this side was not possible (Figure-1). Now we had to wait till the area on the right side is clear from infection while the temporary wire is in cito.

After 10 years of implantation the abdominal pulse generator depleted. Patient came for box change. Both the subclavian areas were clear of infection by now, but the left upper limb veins were fibrosed and blocked (figure 1 right), so the pacemaker was implanted on the right subclavian area again. But after a couple of years of implantation the lead got displaced and the patient presented with ventricular escape rhythm. Temporary pacemaker (TPM) implanted for backup. Patient was shifted for procedure but now the right-side subclavian veins were also fibrosed (figure 1 left) and blocked. A Percutaneous coronary intervention (PCI), guide wire failed to negotiate the blockage for dilatation and reimplantation. Now both the upper limbs were draining through collaterals and both sides were unsuitable for implantation.

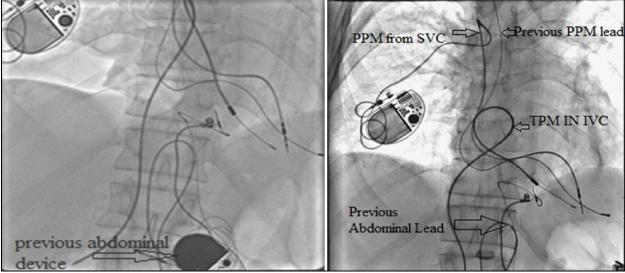
Figure-2: Position of previous PPM, PPM leads, TPM lead still hanging in IVC and abdominal device visible

But the temporary wire got fractured and divided into two portions. The reasons for this unfortunate and strange event remain astonishing. The distal end of the lead inside the patient body totally separated from the external end. The cut end inside the inferior vena cava can still be seen inside the body which was also not pulled out because we were unable to snare it and patient was not willing for extra surgical procedure. (Figure-3).

The right subclavian area was still not suitable for implantation due to the infection. So, without any further delay patient was shifted to cardiac surgeon for abdominal implantation. The abdominal device can be seen in figure 2.
